PHOTOGRAPHIC INTERPRETATION REPORT

SELECTED TRANSPORTATION

COMPENDIUM

NPIC/R-368/66 NOVEMBER 1966

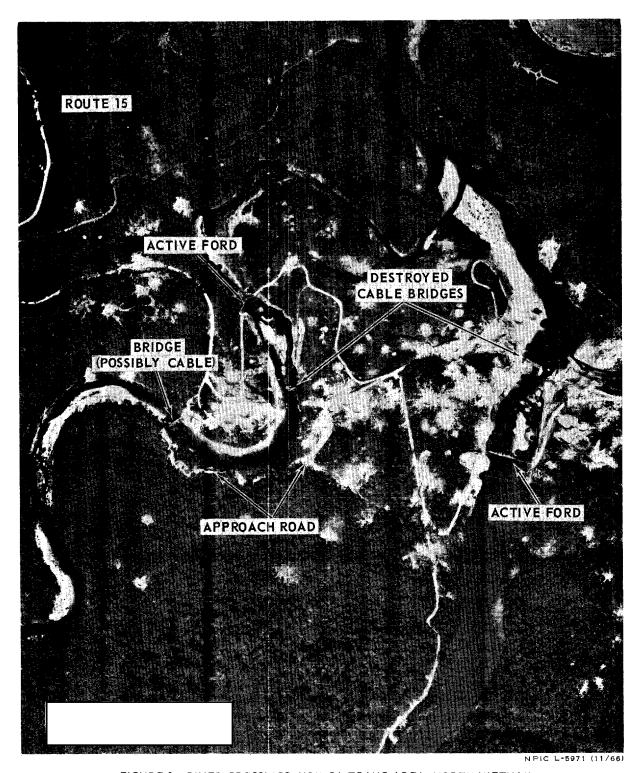
Continuing bridge and road construction on Routes 15 and 1502 in the Xom Ca Trang area (17-57N 105-48E) indicates a determined effort to maintain the supply route from North Vietnam into Laos via the Mu Gia Pass. The approaches of the original cable bridges at the Xom Ca Trang Highway Bridge over the Nam Quat $\sqrt{}$ and the Xom Ca Trang Highway Bridge over the Rao Cai have been destroyed by air strikes and the bridges have been abandoned. fords at UTM WE864861 and UTM WE861855 are active and permit through traffic on Route 15 (Figure 1).

A newly constructed bridge (possibly a cable bridge) with approach roads provides an alternate crossing over the Nam Quat at UTM WE859859. During the early stage of construction, a cable and a T-shaped anchorage were observed at this bridge. Decking is now at least partially supported by a pier and two A-frames, and the entire bridge is [(Figure 1).

FIGURE 1. RIVER CROSSINGS, XOM CA TRANG AREA, NORTH VIETNAM

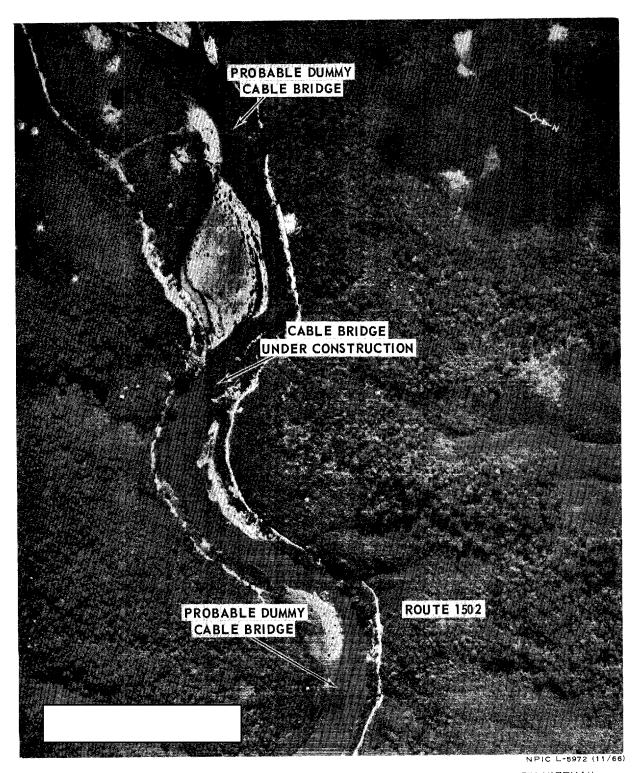
Route 1502 is currently unserviceable as an alternate to Route 15 due to the lack of a river crossing over the Rao Cai; however, a cable bridge is under construction at UTM WE853849. At least five cables have been strung, the anchorages are apparently complete, and the approaches have been Additional cables, which have been strung across the Rao Cai at UTM WE855853 and UTM WE851848, probably represent dummy cable bridges. The approaches have been only roughly cleared; there is no evidence of the necessary cable anchorages; and unlike the bridge under construction at UTM WE853849, the cables are more visible due to their light color (Figure 2).

FIGURE 2. CABLE BRIDGE UNDER CONSTRUCTION, XOM CA TRANG AREA, NORTH VIETNAM

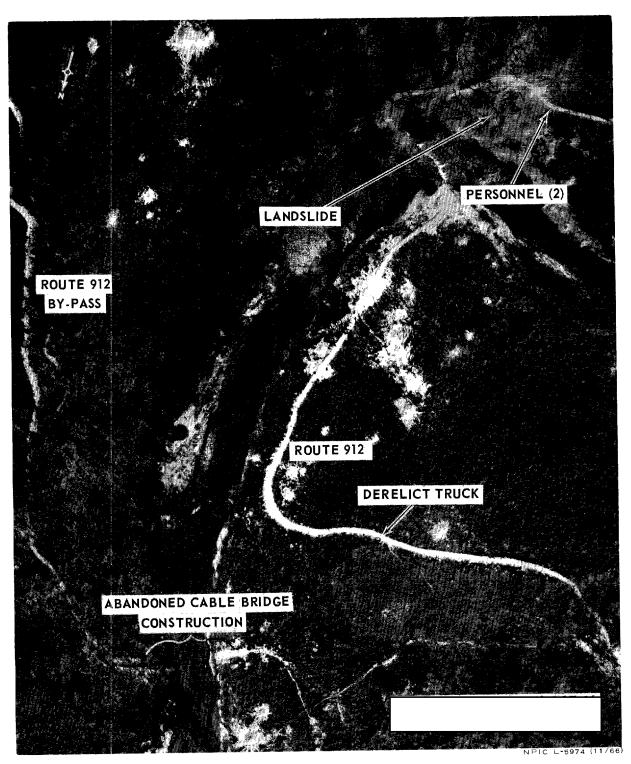
Route 912 was unserviceable ondue to a landslide at
17-12N 106-09E (UTM XE230030), immediately south of the ford across the Nam Ta Le (river). Only a short segment of the road was affected
(Figure 3) and by the area had been cleared and was again open to vehicular traffic. The by-pass road east of the ford is over-
grown in the vicinity of the river, and the cable bridge construction at UTM XE231025 has apparently been abandoned. Due to the ford and the
soil instability observed along the ridgeline immediately south air
strikes could seriously affect the serviceability of Route 912 in this area.

FIGURE 3. ROAD CONDITIONS, ROUTE 912, LAOS

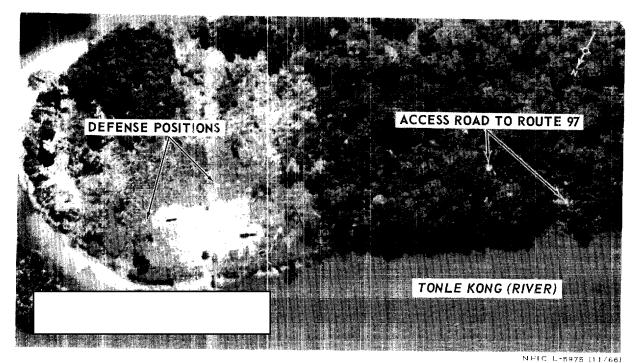
A military cambered transshipment point has been observed at the confluence of the Tonle Kong (river) and an unnamed stream at 14-33N 106-29E (UTM XB609107), and consists of two large buildings and five sheds with a perimeter defense formed by approximately 20 foxholes (Figure 4). Vehicle tracks extend from a heavily wooded area immediately south of the facility and jurction with Route 97 at UTM XB604099.

FIGURE 4. MILITARY CAMP AND TRANSSHIPMENT POINT, TONLE KONG (RIVER), CAMBODIA

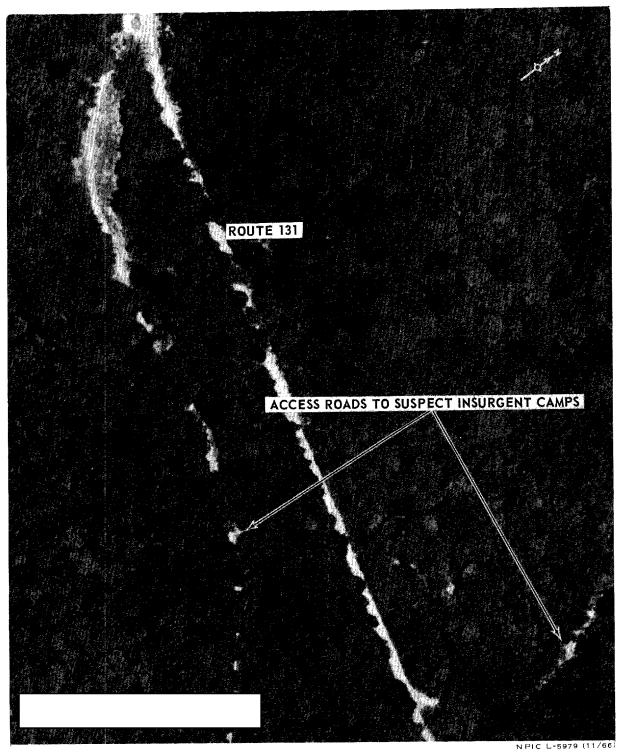
FIGURE 6. ROAD JUNCTIONS (12-07N 106-35E), ROUTE 131, CAMBODIA
